CENTRAL INTELLIGENCE AGENCY

COUNTRY	USSR (Odessa Oblast)	REPORT	
SUBJECT	1. Port of Odessa 2. Soviet Naval Vessels 3. Military Exercises Employing Paratroopers	DATE DISTR.	20 November 1956
DATE OF INFO.		NO. OF PAGES	1 25X1
PLACE ACQUIRED		REFERENCE	(LY/ISO) 25X1
DATE ACQUIRED			This is UNEVALUATED Information

U.S.S.R.Naval/AirRUSSIAN WARSHIPS AT ODESSAODESSA

U.S.S.R.Naval.Port of ODSSA.

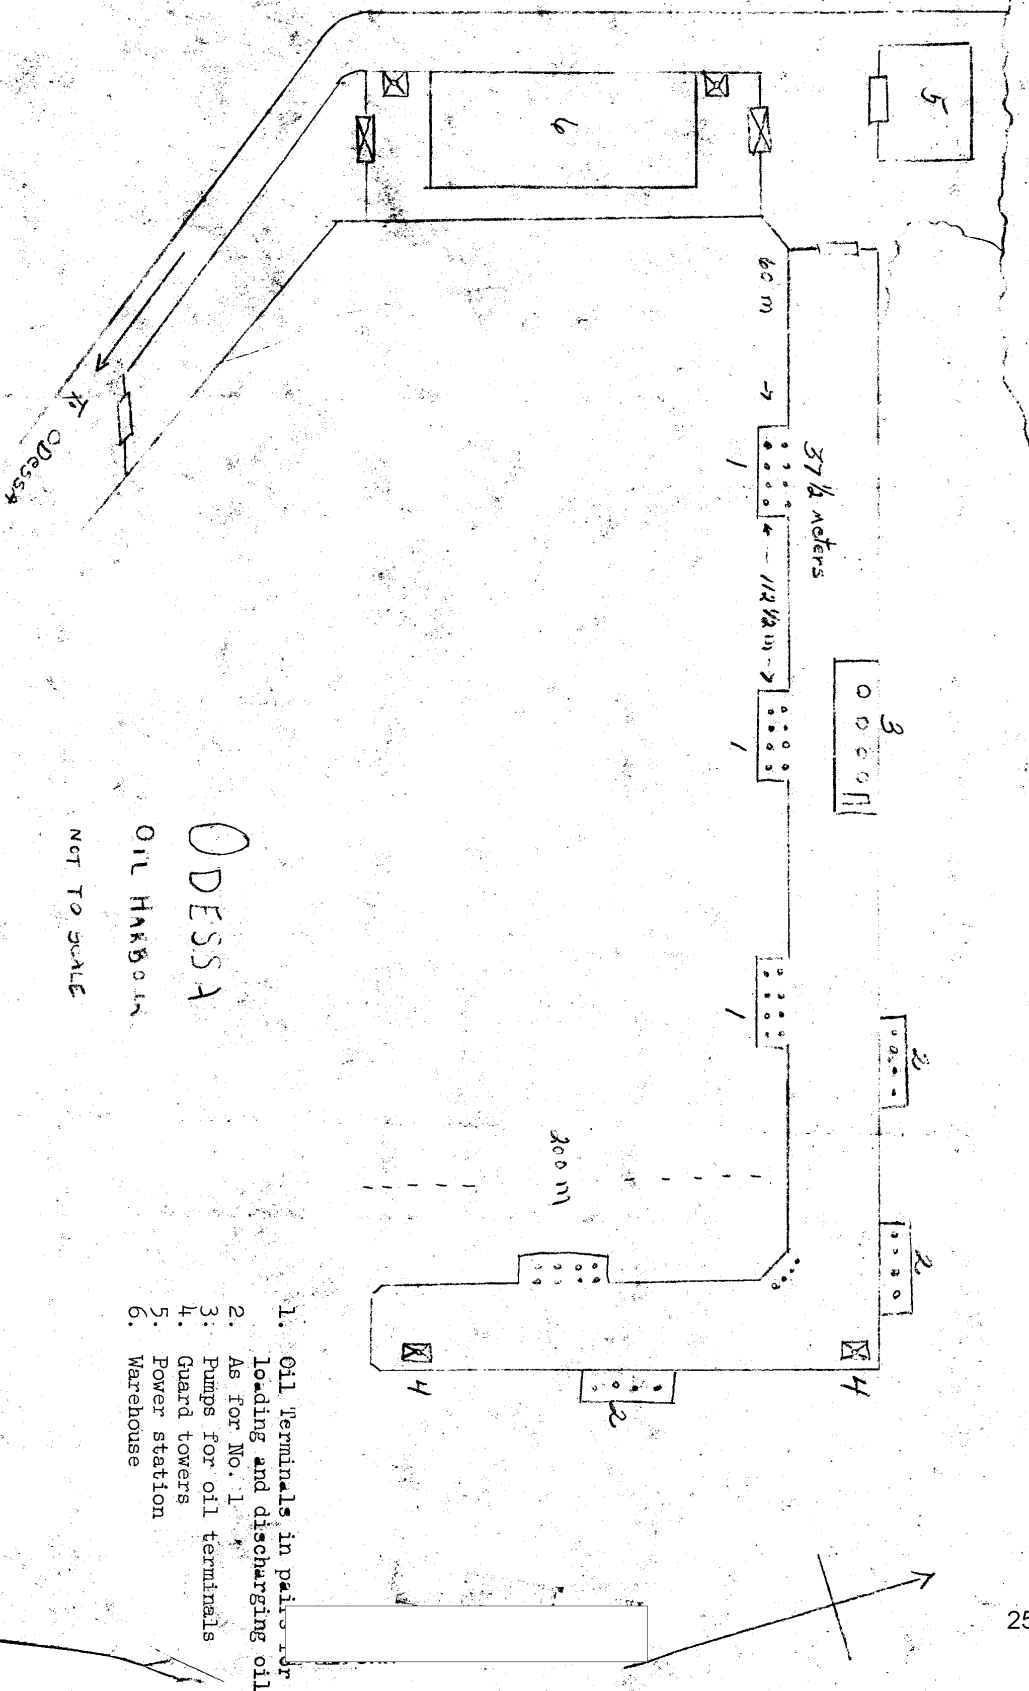
1. Oil terminals in pairs for loading and discharging oil
2. As for No. 1
3. Pumps for oil terminals
4. Guard towers
5. Power station
6. Warehouse

- a) Details of oil harbour as per attached plan. Oiling of an 10,000 ton tanker took about two full days, but can be done in ten hours if necessary (i.e. 1,000 tons per hour). Two grades of oil are available. A light oil for "small fast ships" and heavy oil for cargo ships.
- b) Even the smallest tug seen in the harbour was equipped with radar.
- c) Destroyers over 1,000 tons
- d) Destroyers/corvettes of about 500 to 1,000 tons
- e) One tanker of about 10,000 tons was seen to be under construction in the Machine Shop.
